# Qualitative Infrared Survey of Building Heat Loss

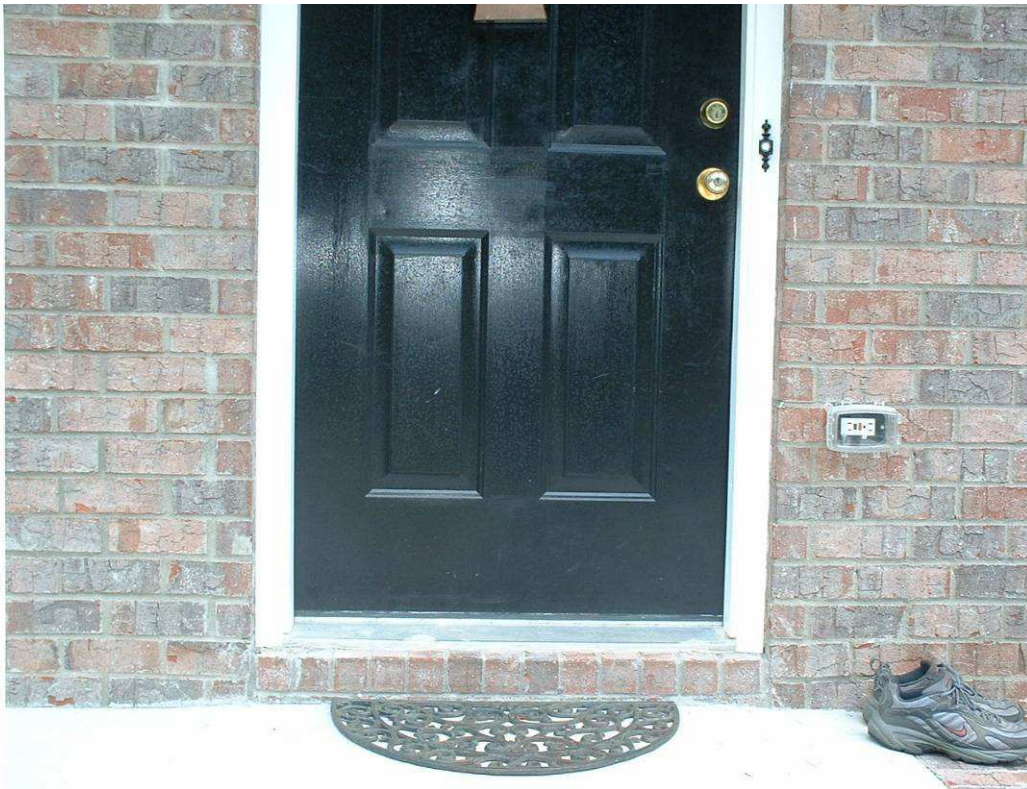
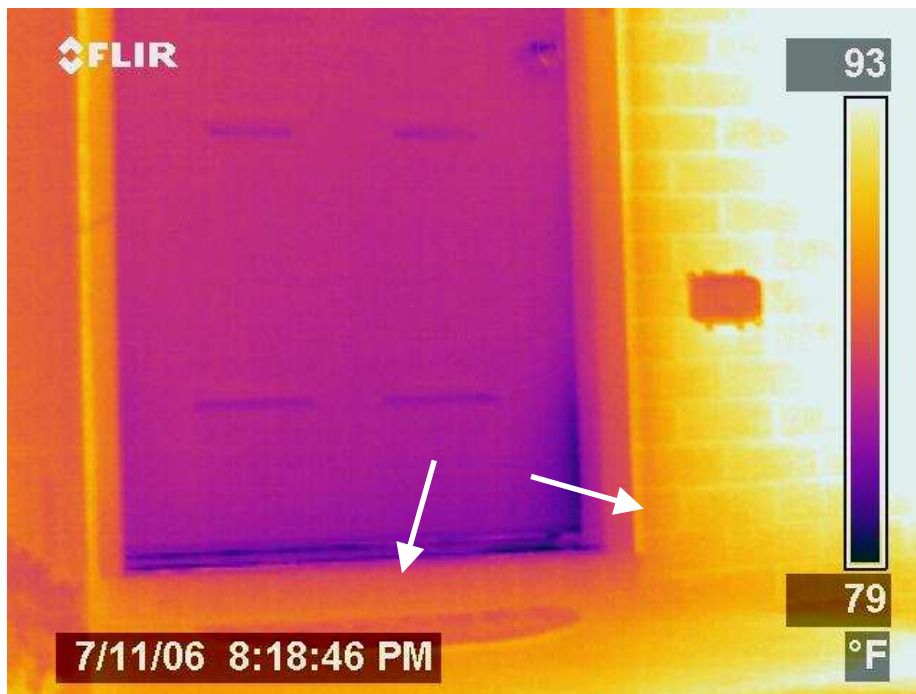
**Location:** Front Entrance

**Notes:** Show air leakage at door.

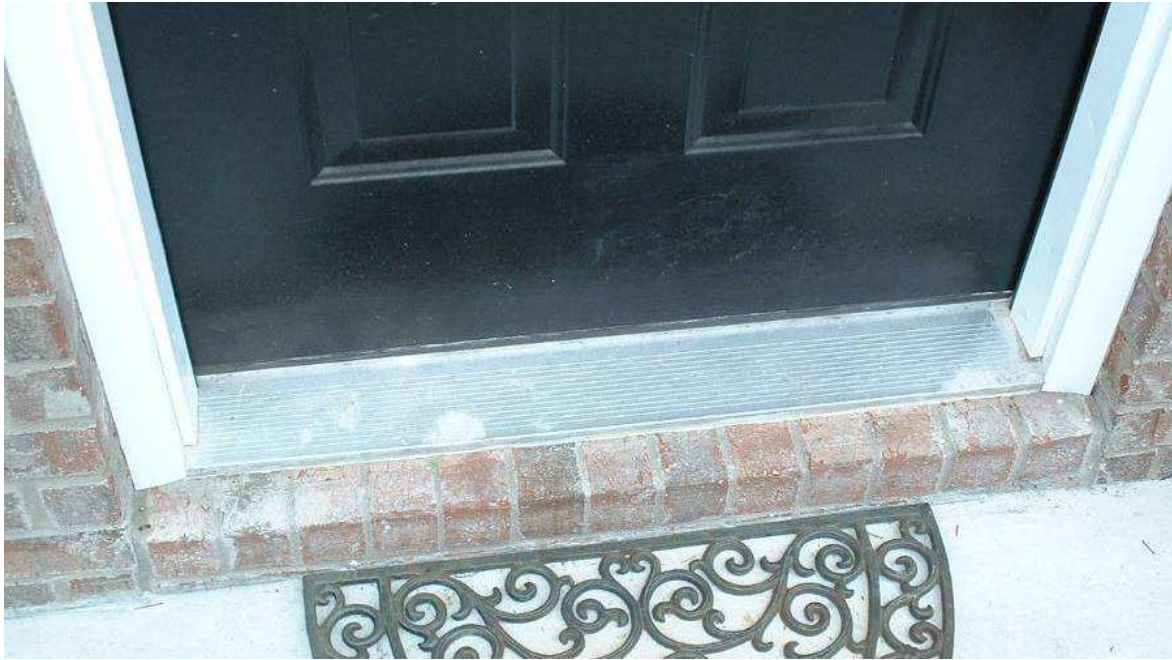
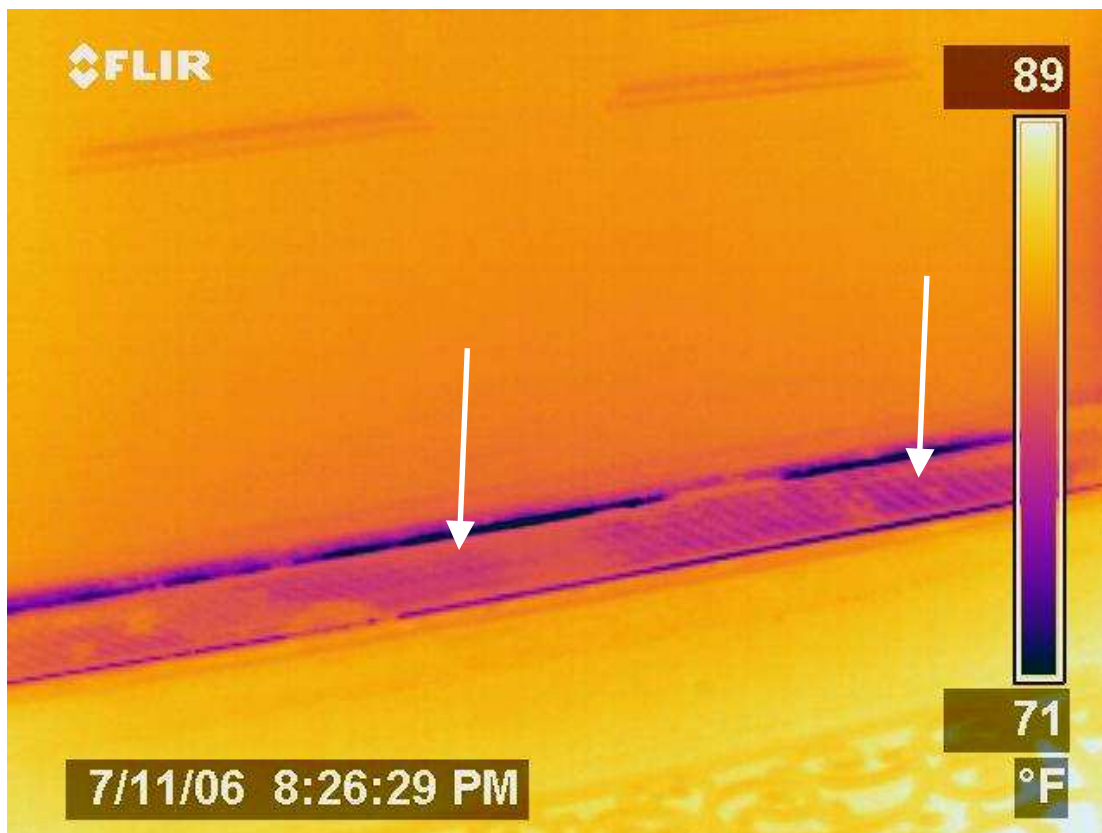
**Location:** Front Entrance

**Notes:** Show air leakage at door.

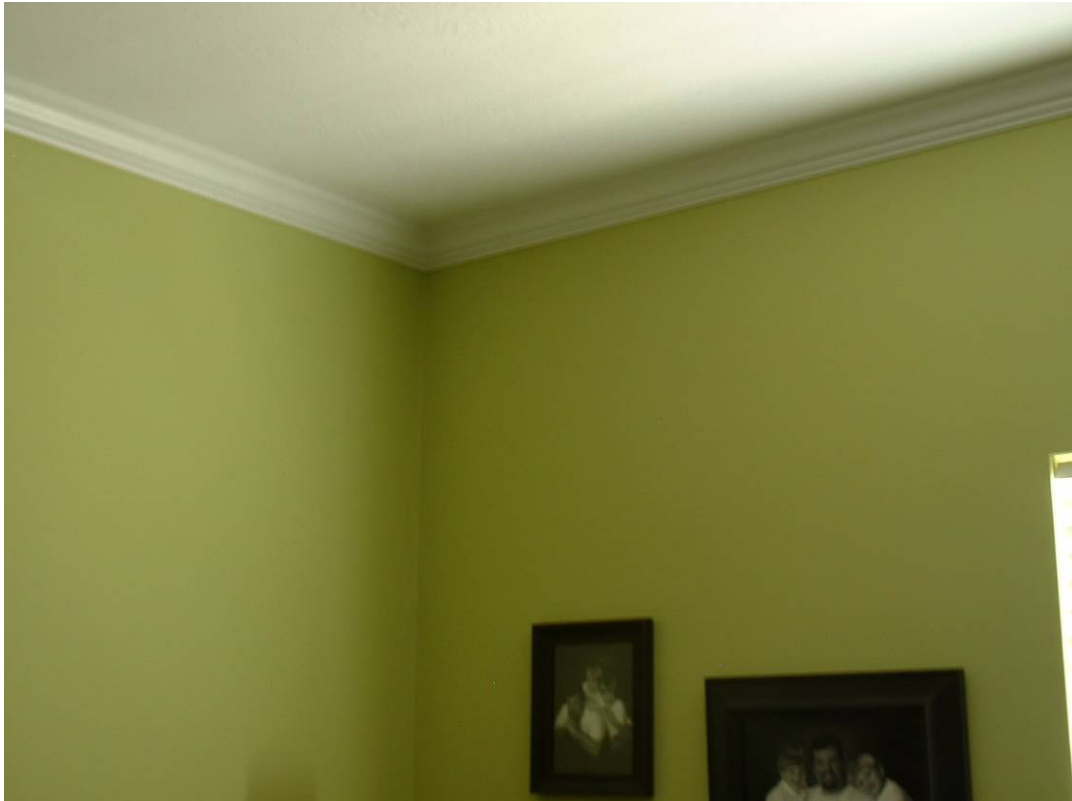
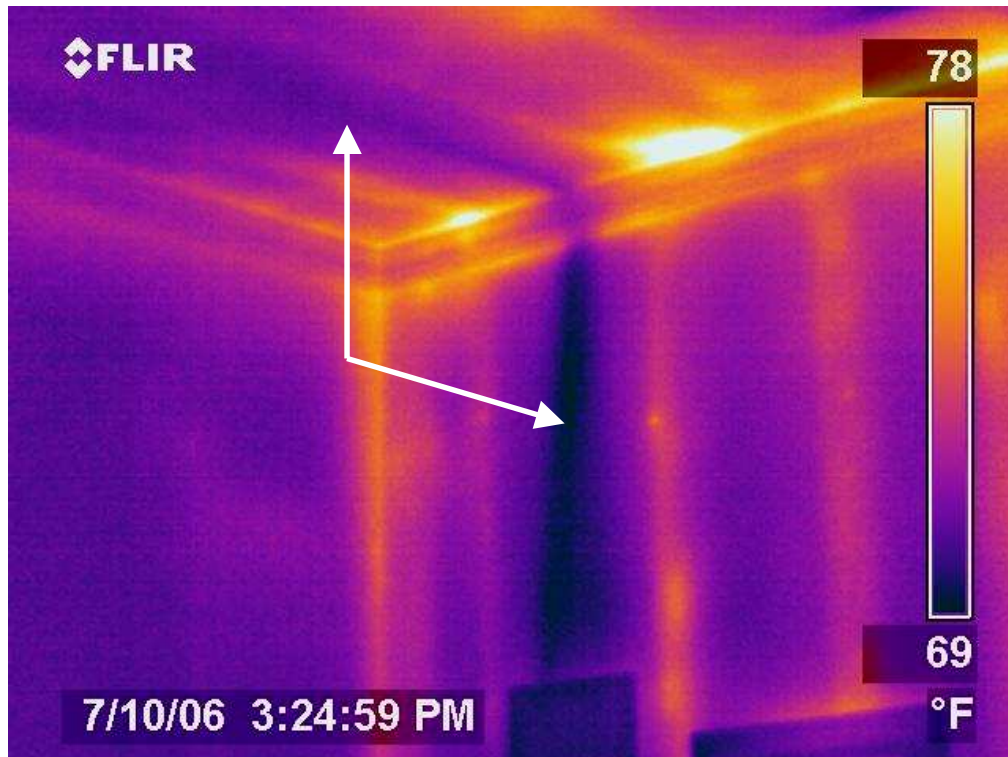
**Location:** Master Bedroom, North Wall

**Notes:** Shows heat loss at top of wall (missing insulation) and AC line (cold spot indicated with white arrow) which can leak water (from condensation) inside wall.

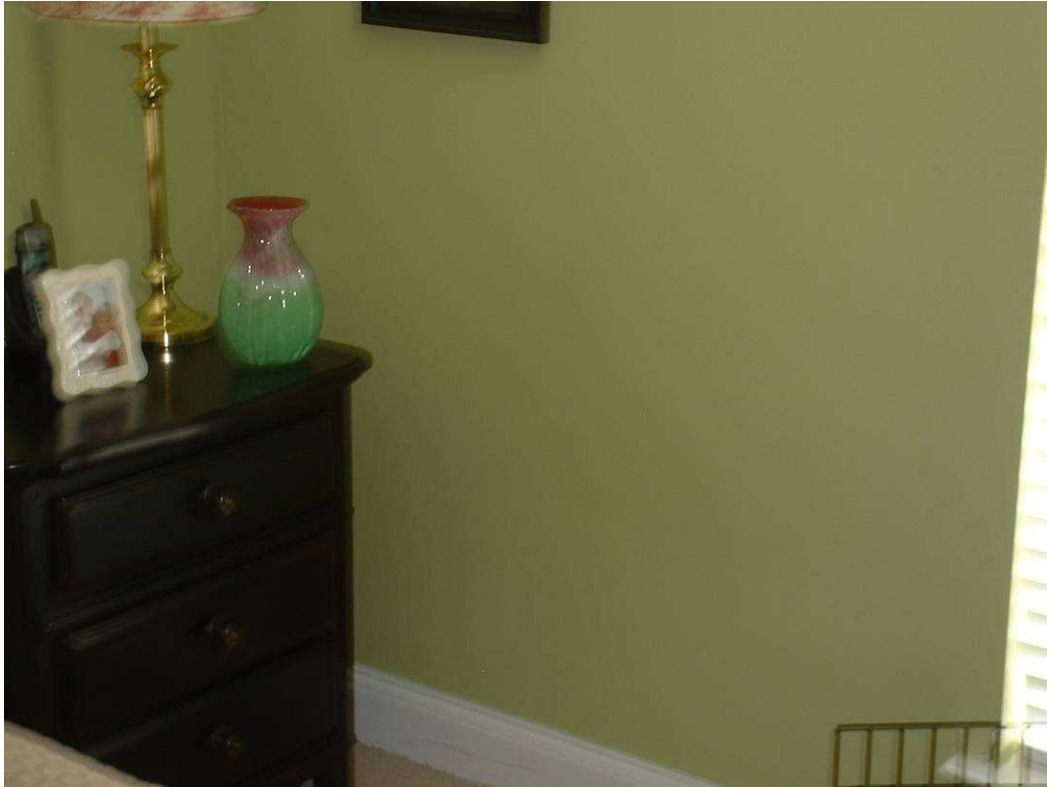
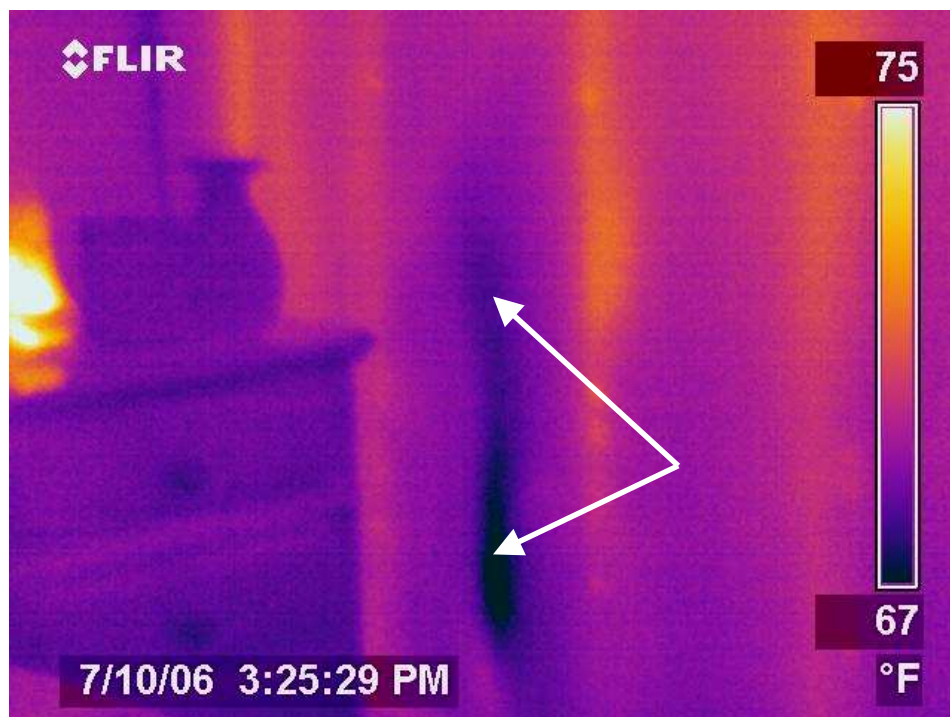
**Location:** Master Bedroom, North Wall

**Notes:** Shows AC line (cold spot indicated with white arrow) which can leak water (from condensation) inside wall.

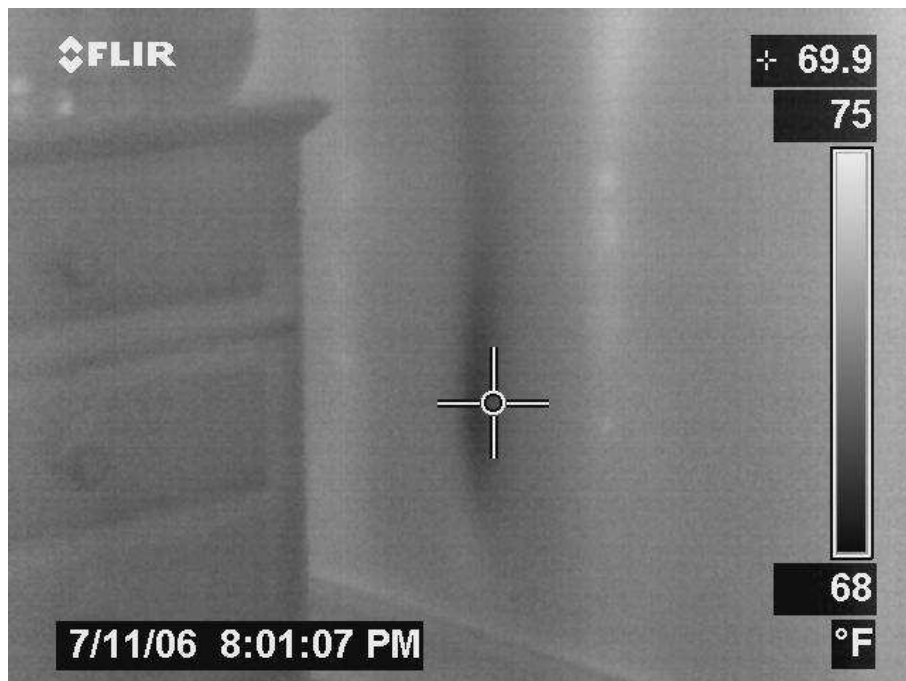
Inside view

**Notes:** Shows AC line (cold spot indicated with white crosshair) which can leak water (from condensation) inside wall.

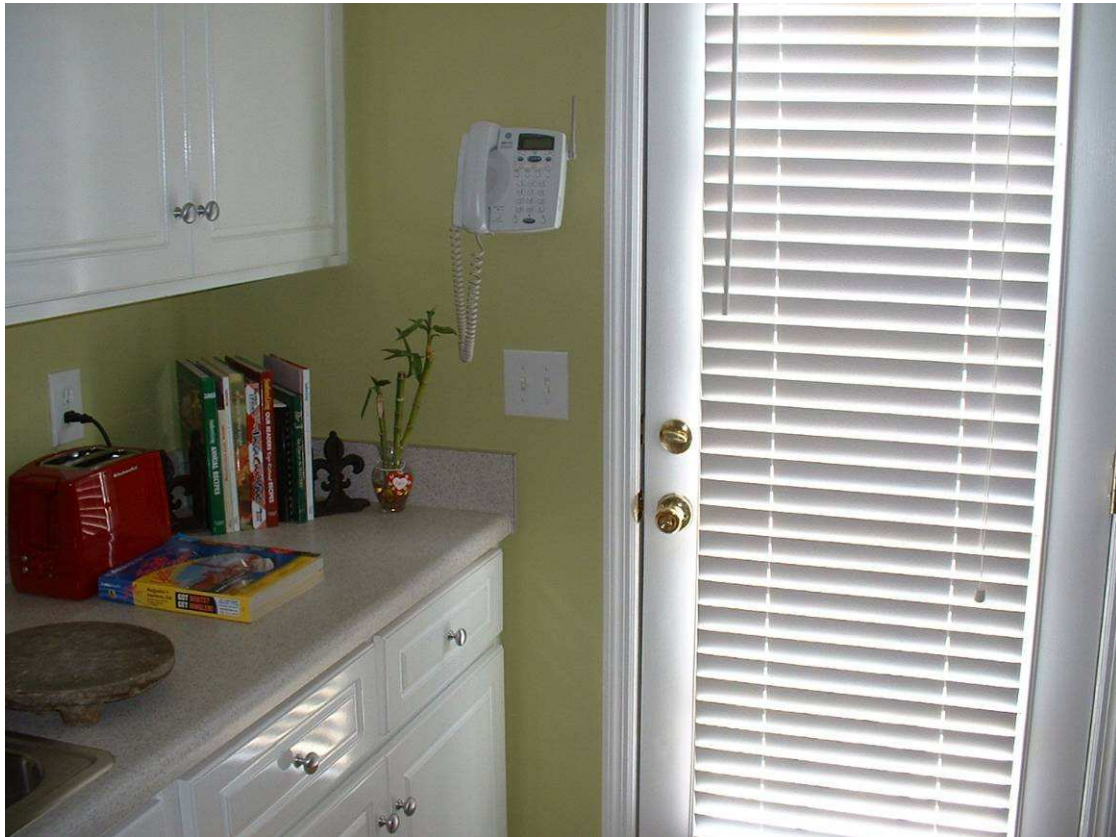
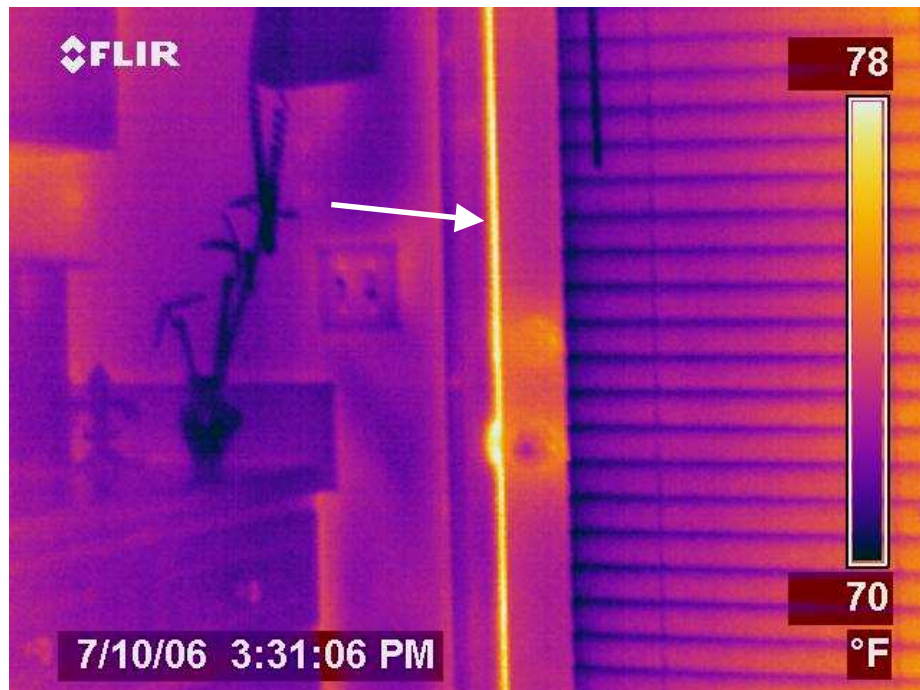
**Location:** Kitchen Rear Entrance

**Notes:** Shows door seal leaking.

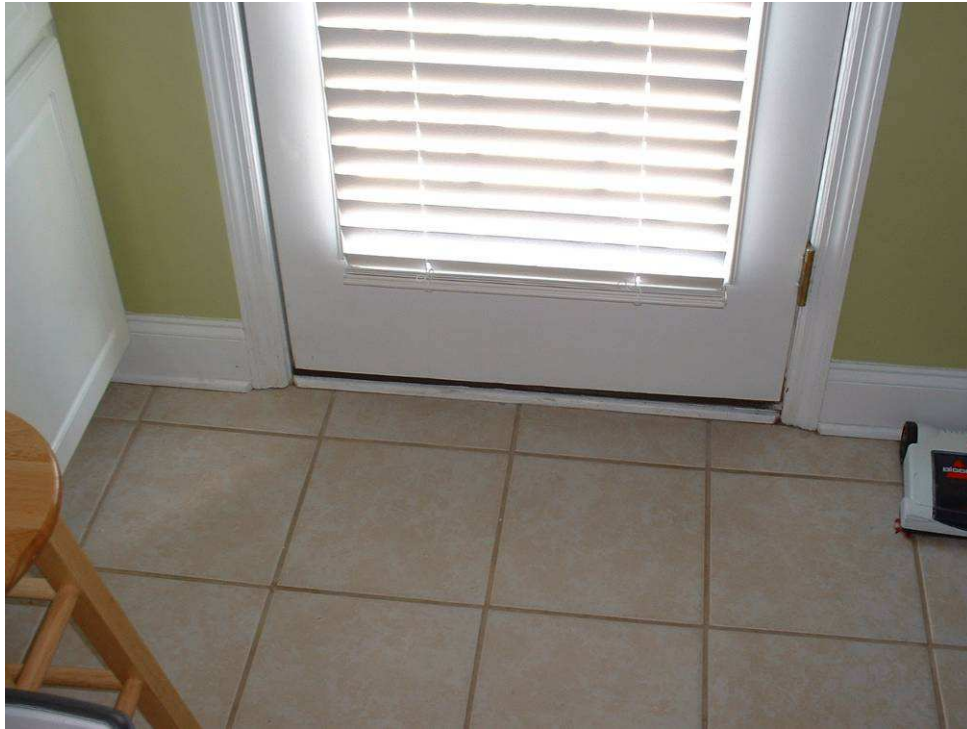
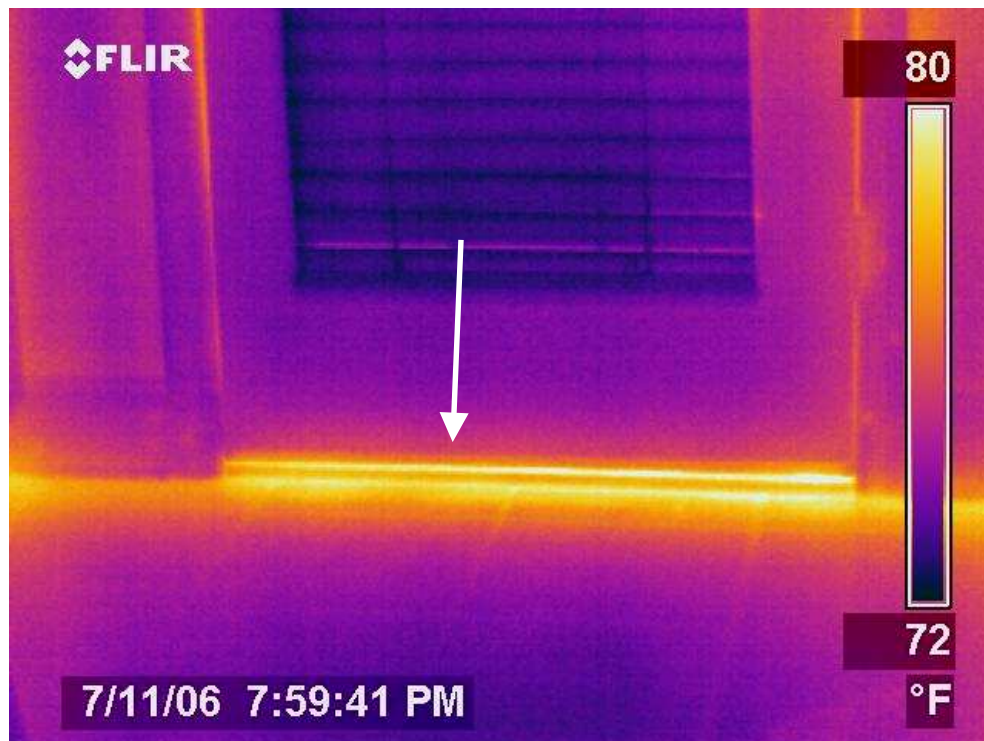
**Location:** Kitchen Rear Entrance

**Notes:** Shows door sweep not properly sealing.

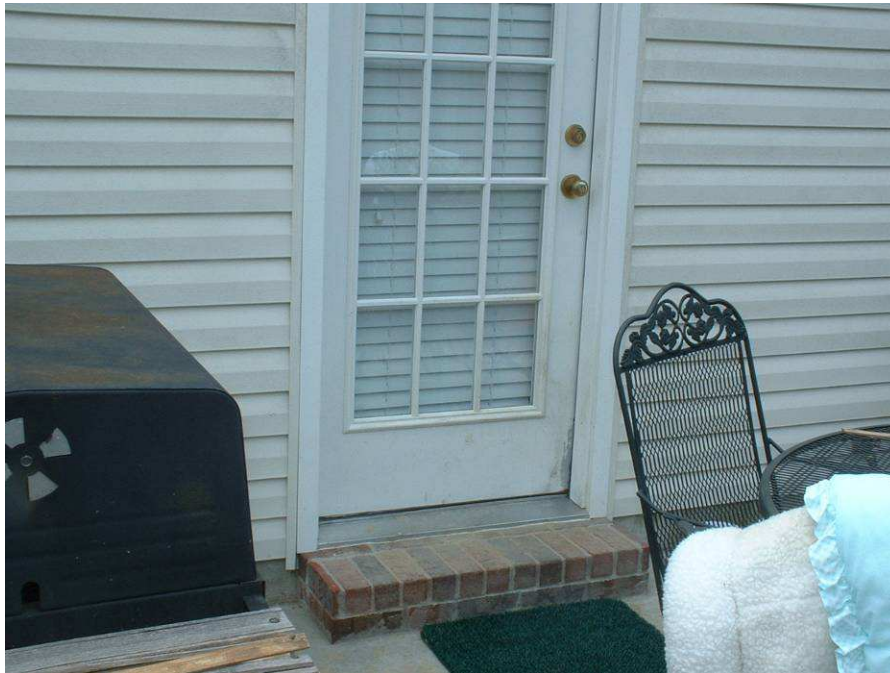
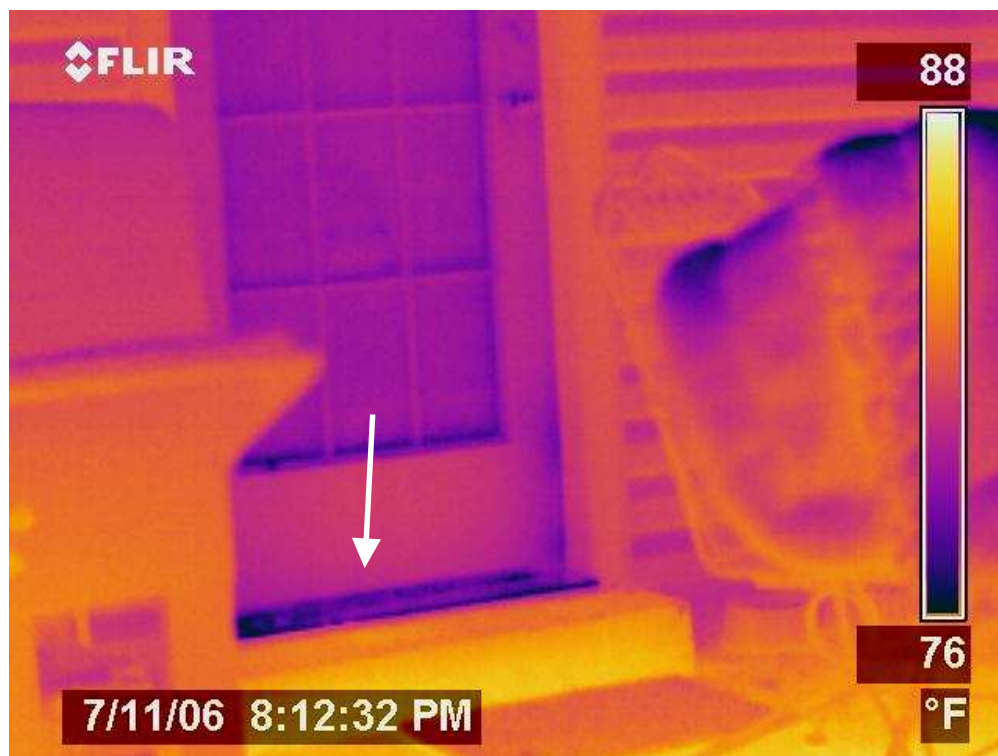
**Location:** Kitchen Rear Entrance

**Notes:** Shows door sweep not properly sealing.

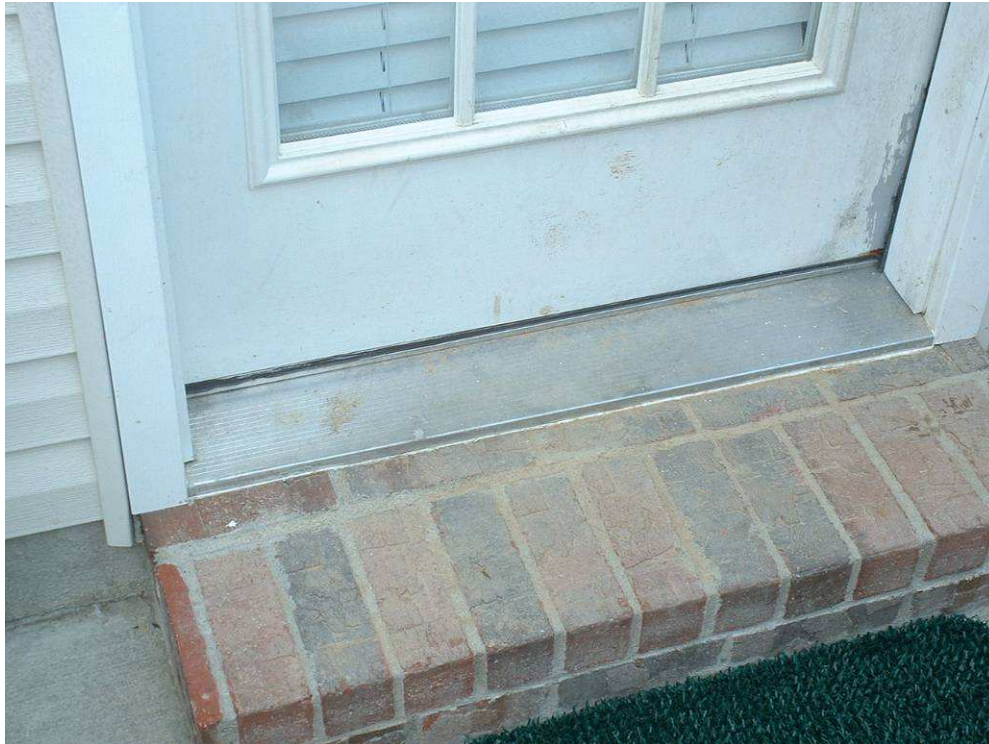
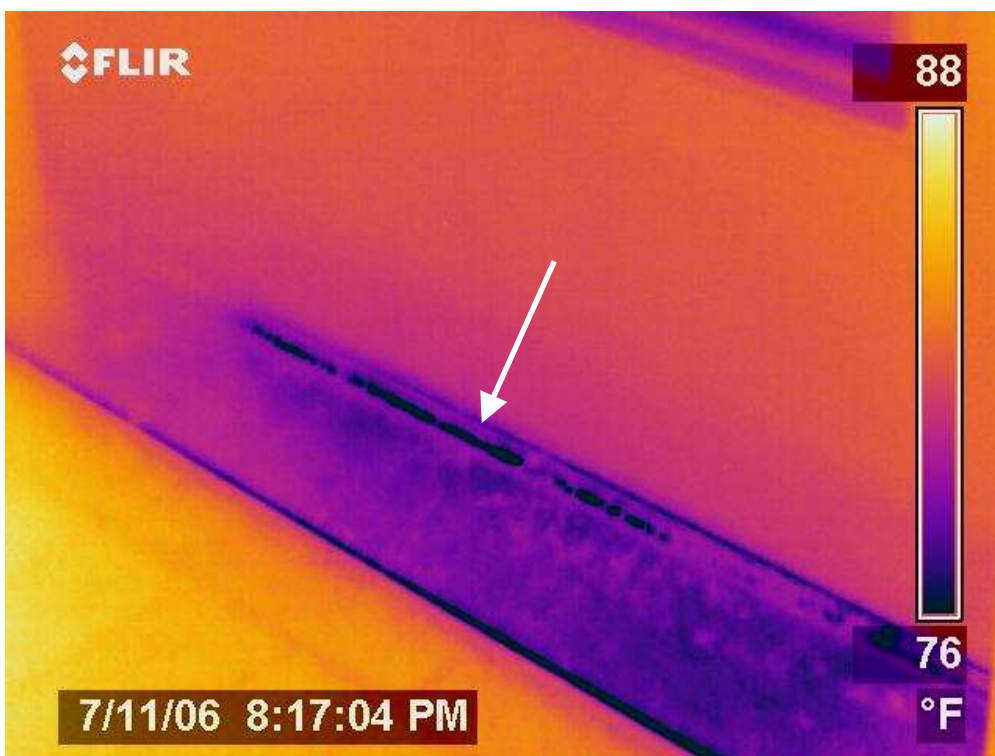
**Location:** Kitchen Rear Entrance

**Notes:** Shows door sweep not properly sealing.

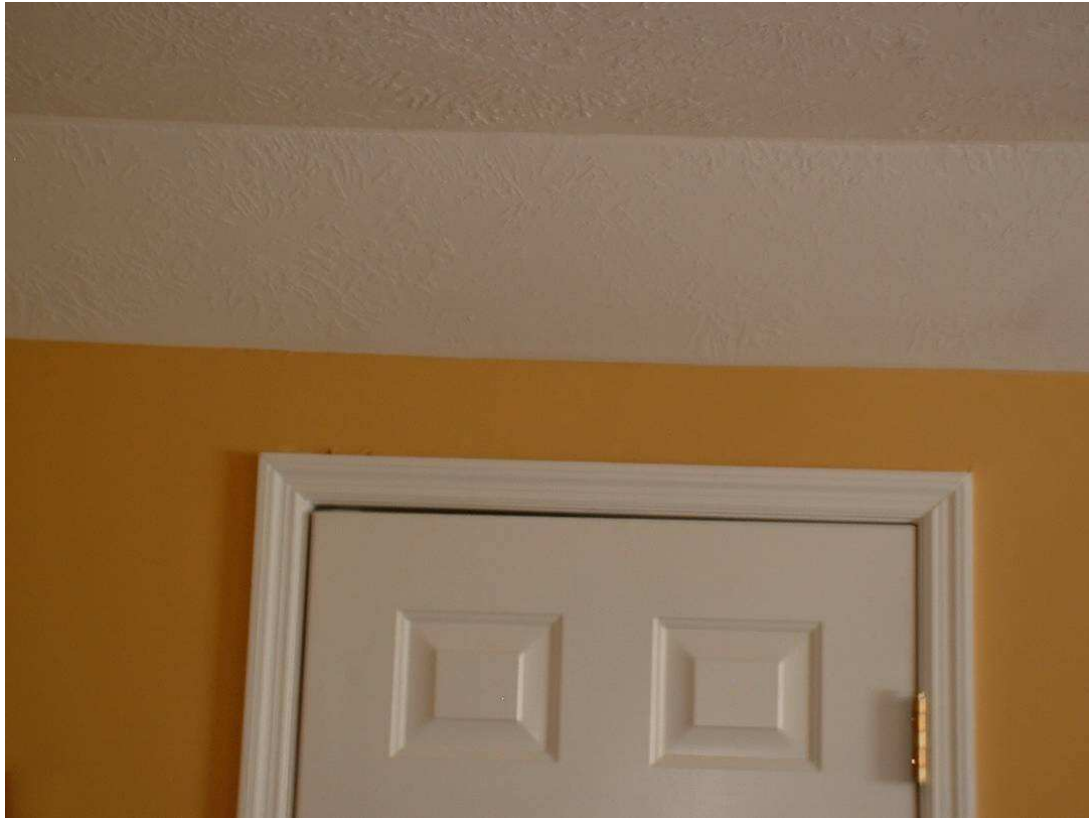
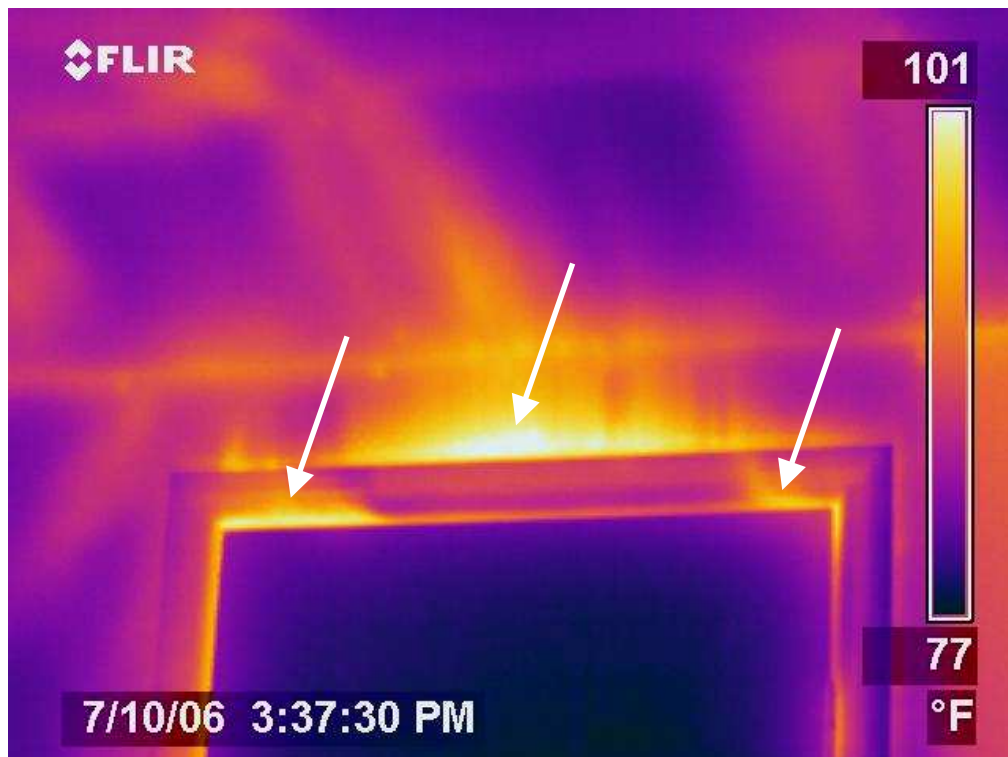
**Location:** 2<sup>nd</sup> Floor Kneewall Attic Door

**Notes:** Shows large air leak at top of door.

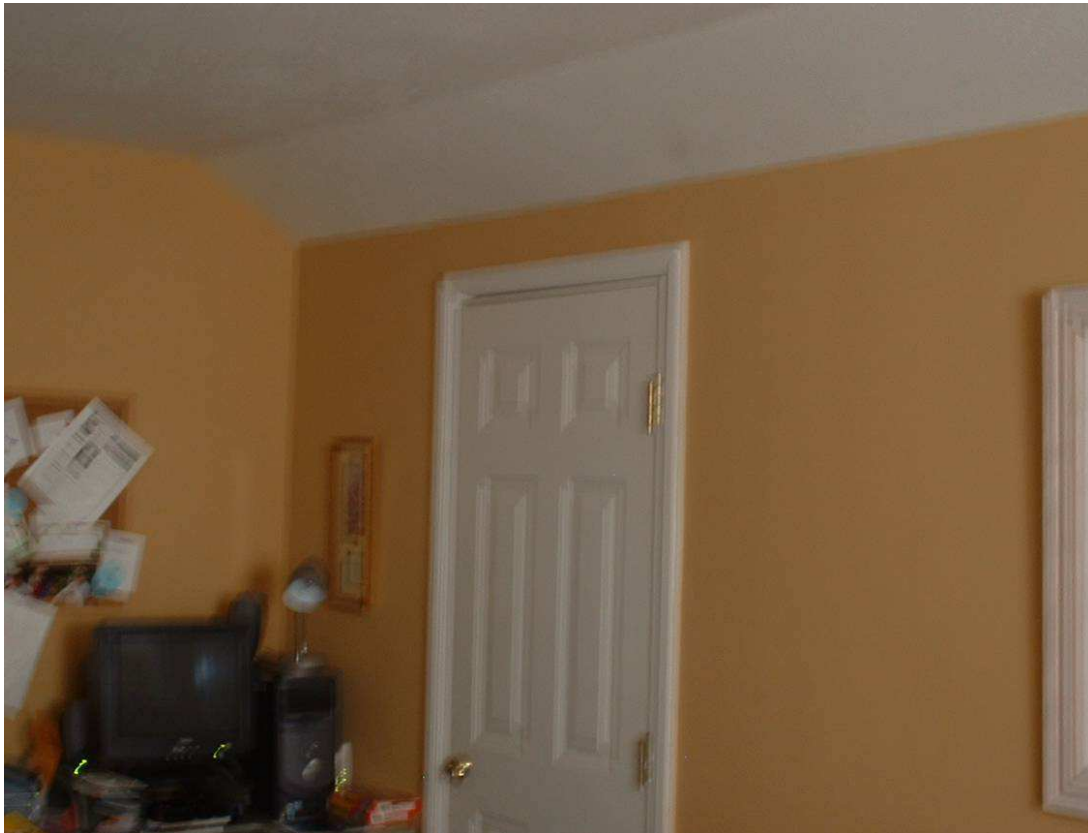
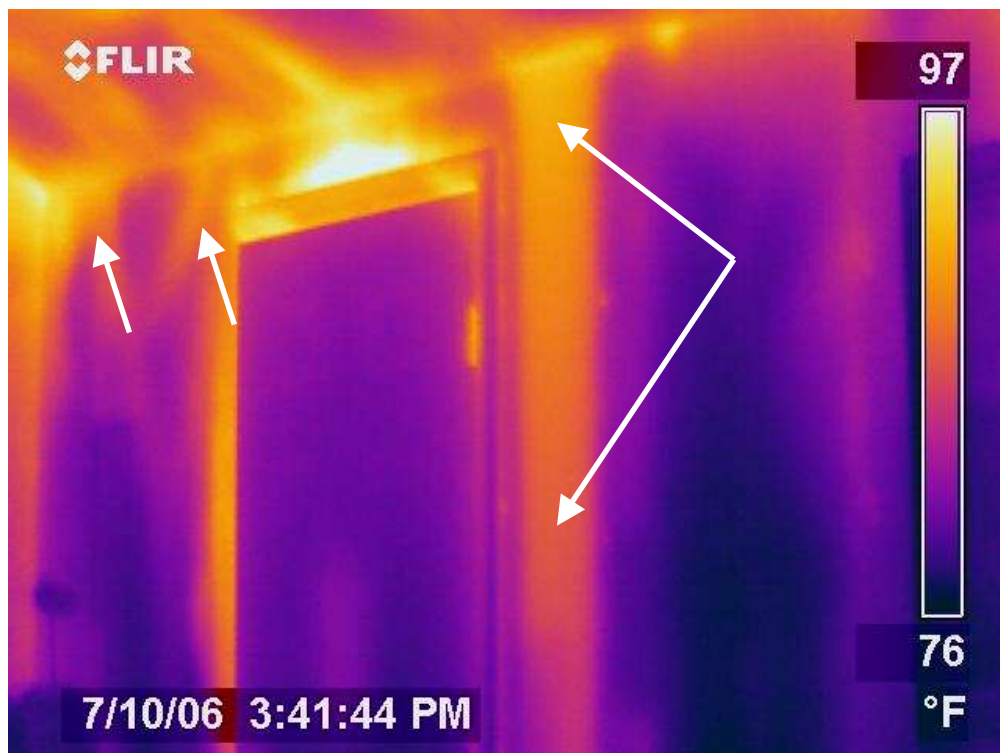
**Location:** 2<sup>nd</sup> Floor Kneewall Attic Door

**Notes:** Shows area of missing insulation beside door.

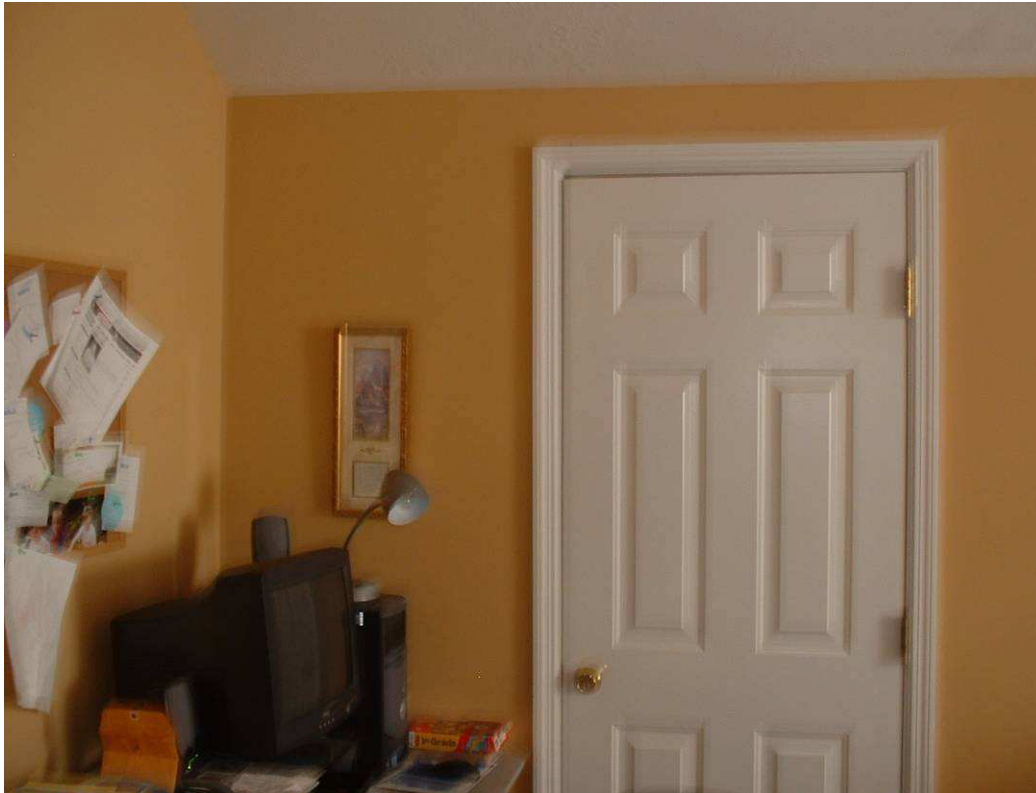
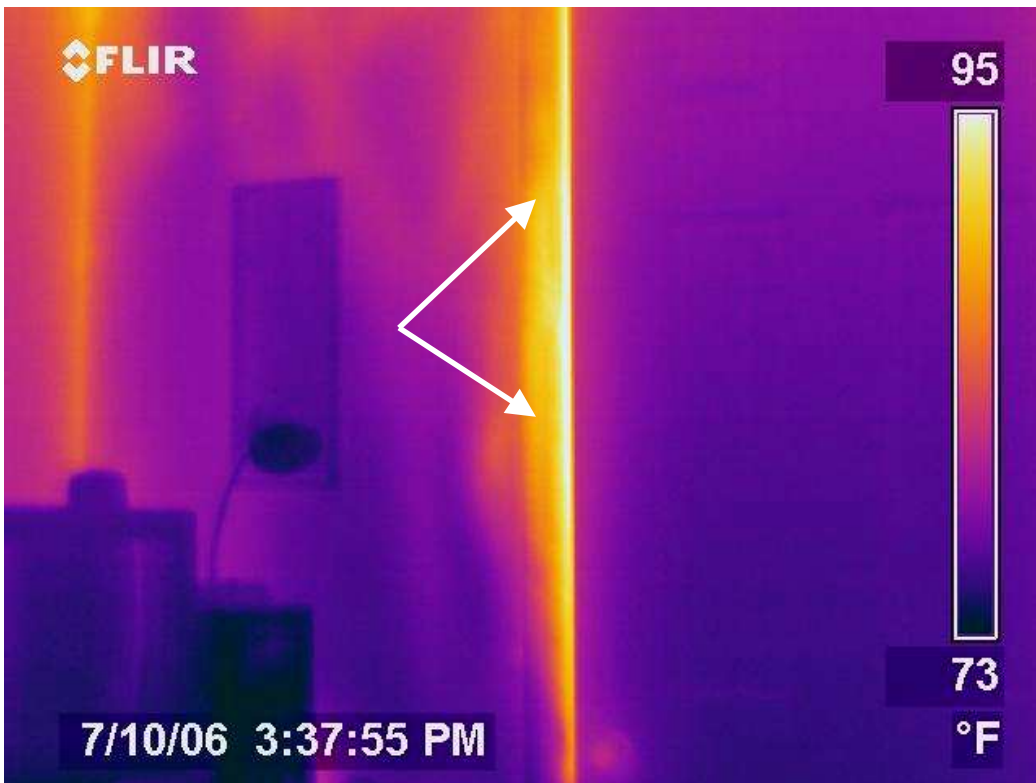
**Location:** 2<sup>nd</sup> Floor Kneewall Attic Door  
**Notes:** Shows large air leak at side of door.

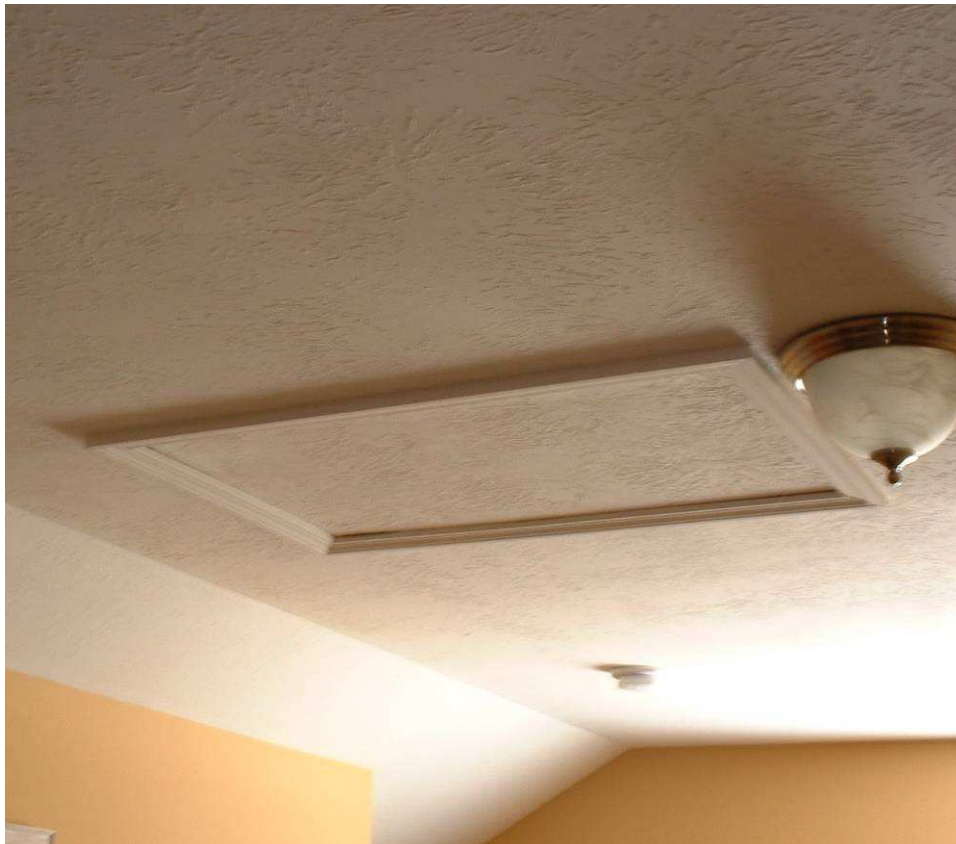
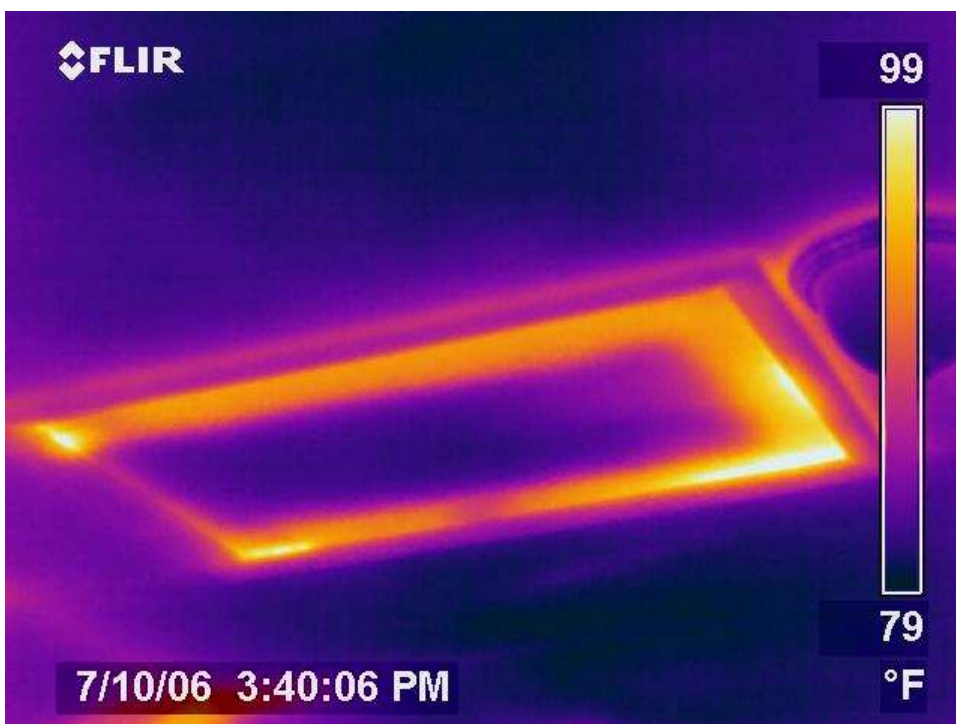
**Location:** Attic Entrance

**Notes:** Shows attic door not properly insulated.

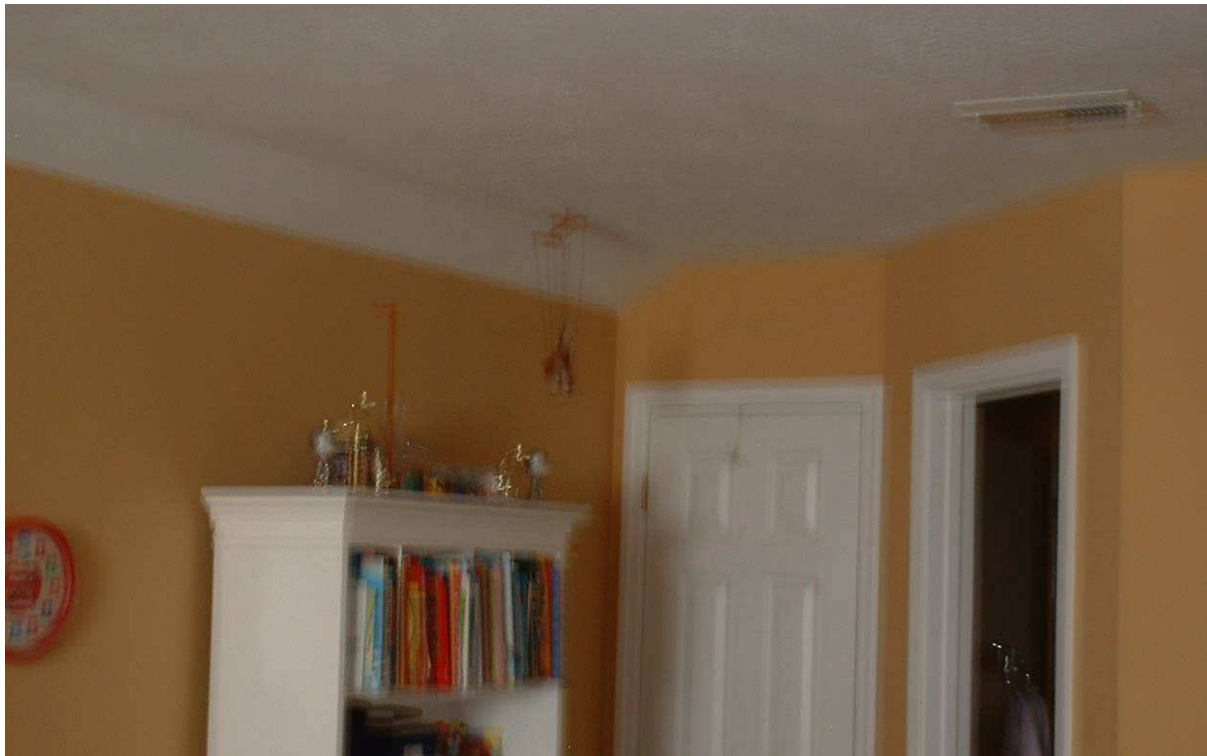
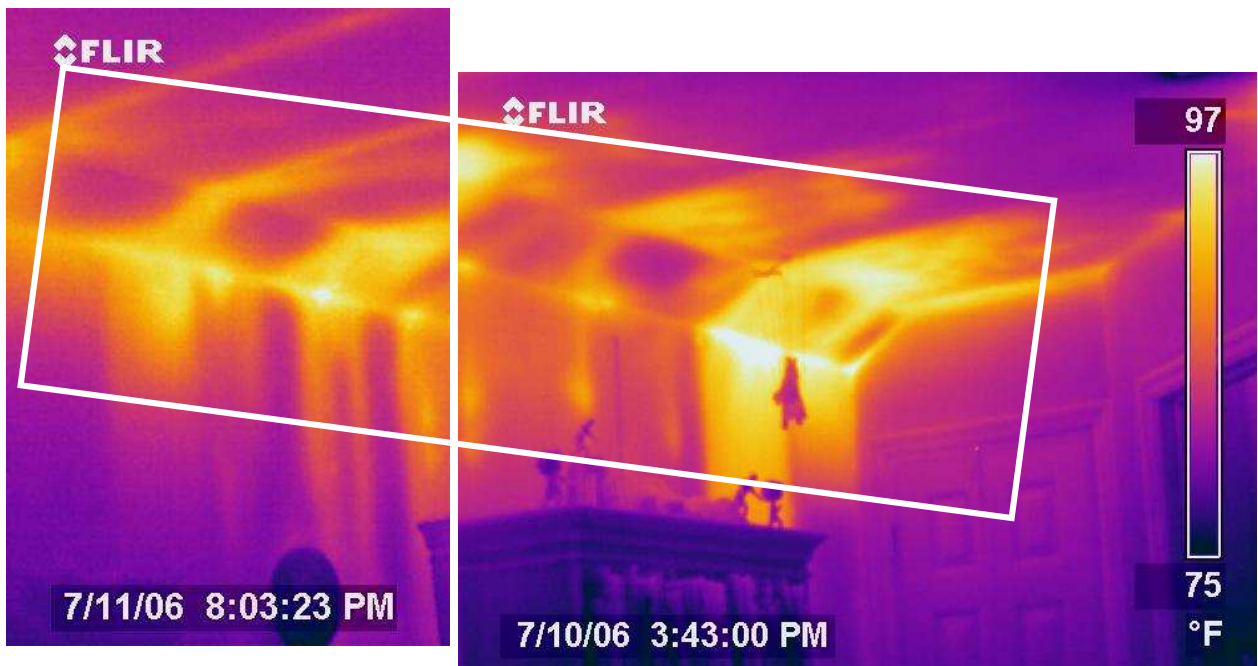
**Location:** 2<sup>nd</sup> Floor, Southwest Corner and Wall  
**Notes:** Shows large areas not properly insulated.
